4 Fall from elevation--Inspection #1377946 Alex Ulloa

A **36 year old male** employee was fatally injured when he **fell 16'5"** from the stair landing between the 2nd and 3rd floors of an apartment complex under construction.

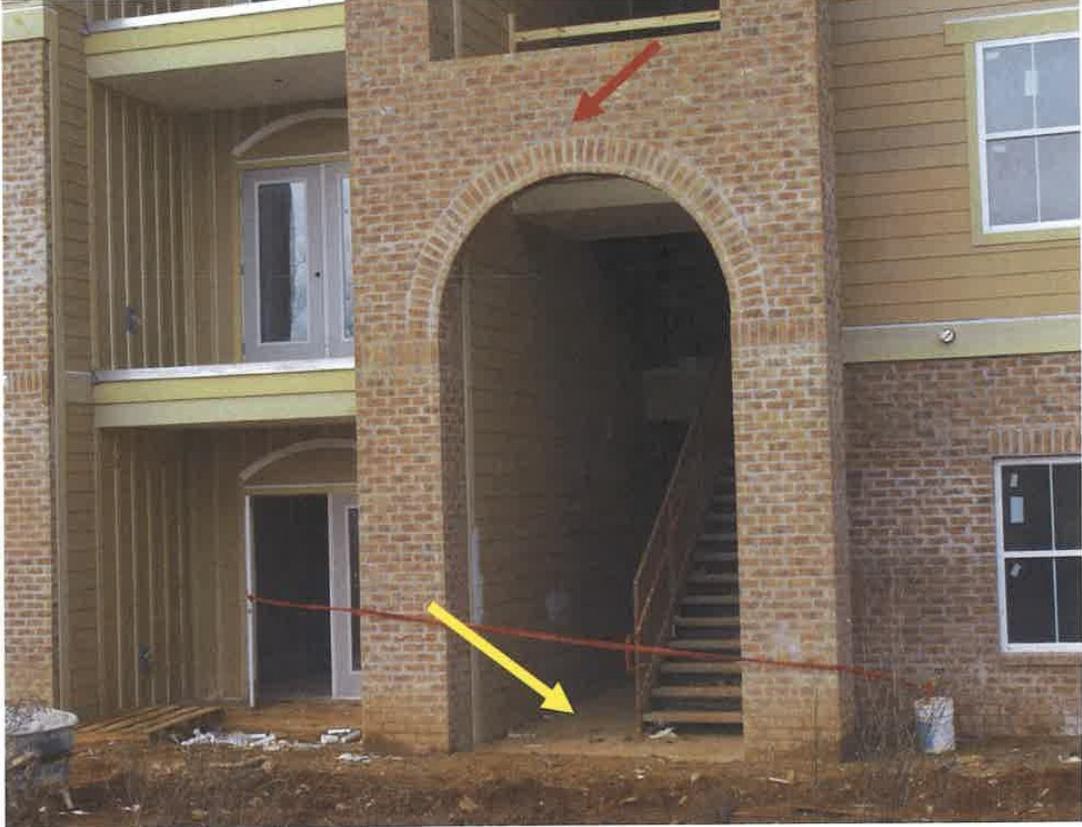
It was determined that at the time of the incident, the victim was leaning out away from the landing to fill nail holes in the wood siding with wood filler putty. The employee who was working with him stated that he lost his balance while reaching out to fill a nail hole and fell off of the landing. There was no guardrail system in place when the victim fell.

The red arrow indicates the approximate location of the employee before falling. The blue arrow indicates the **guard rail system which was put in place after the incident.**

In that two employees were working at a height of 16'5" without being protected from falls. The employees were working on the North side of building number 9, on the stairway landing between the 2nd and 3rd floors.
